Performance of Buried 3CR12 Pipes in Various Soil Environments

In 1988 a five-year sub-soil exposure programme was commissioned by MS&A on the suitability of 3CR12 for buried pipelines. The pipelines were to be used for the carriage of potable water, the objectives of the study being merely to determine the exterior corrosion resistance of 3CR12 in various soil backfills.

This paper reports on the results of two inspections, one in the PWV area and one in the Durban area. Many municipalities are facing costly replacements of cast-iron and wrought carbon-steel pipes owing to exterior corrosion. It can be shown that bare 3CR12 can be used in buried applications provided that a number of simple rules are adhered to. These include the provision of a relatively inert (biologically) free-draining backfill and proper pickling and passivation of fabricated areas.

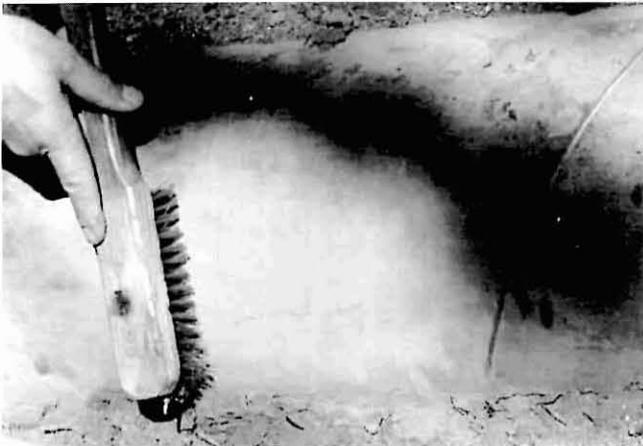
Where the pipes had been laid in dry or well-drained conditions, no corrosion was noted. This accounted for eight of the eleven sites inspected. The excellent condition of the 3CR12 pipe at Westlake Road in Roodepoort is shown in Figure 1. Three of the buried pipes showed surface staining. These were at Attie and Ninth Streets in Pretoria and at City Deep in Johannesburg. At the time of burial at City Deep, the trench was recorded as being wet. The conditions at Attie and Ninth Streets at the time of pipe burial are unknown. However, the black turf soil of Ninth Street was considered to be corrosive by Pretoria City Engineers. In all the cases of surface staining, the stain was caused either by the precipitation of calcium salts as at Ninth Street, or simply by adhering deposits from the soil such as iron silicates. Although no soil potential or resistivity measurements were taken, it can be assumed that the pipe would provide a common earth ground path. Thus, variations in soil potential could result in the deposition of salts from the soil onto the

FIGURE 1. Bare 3CR12, Westlake Road, Roodepoort

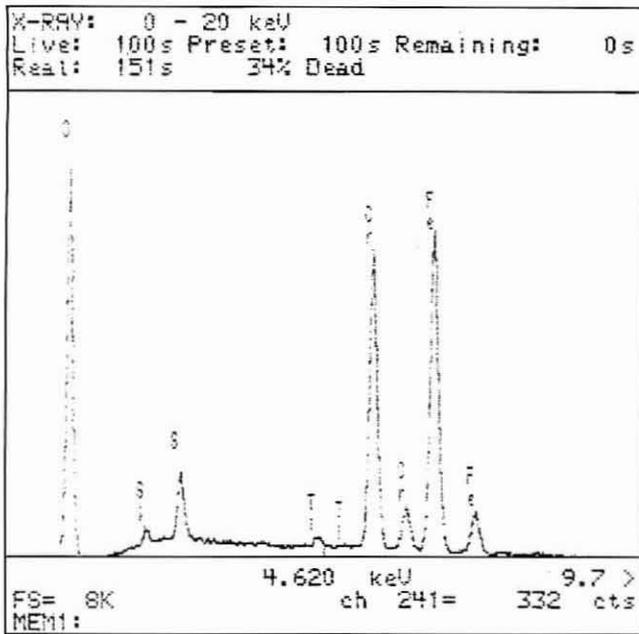
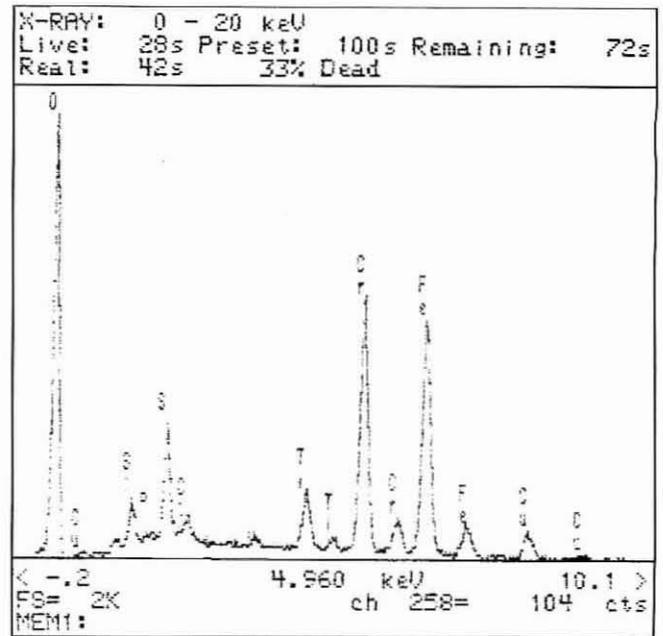
A laboratory examination of the pits from the pipe removed from Anstey's Beach showed the growth of the pits to follow the rolling direction and to be fibrous in nature. At the coated ends of the pipe where attack had occurred, the coating flaked off to reveal a black corrosion product. Figure 2 shows typical energy-dispersive spectra taken from the inside of the pits. A characteristic feature of these spectra is the presence of large amounts of sulphur and the total absence of chlorides. The presence of a black corrosion product together with large amounts of sulphur inside the pits is indicative of MIC. It would certainly appear as if both the apparent crevice attack under the coated ends of these pipes and the etched pitting on the bare surface is the result of MIC. The pitting attack on the Anstey's Beach pipe is shown in Figure 3. The directionality of the attack is clearly evident.

FIGURE 2. Energy-dispersive spectra of the corrosion product at the base of two pits. The high sulphur level should be noted

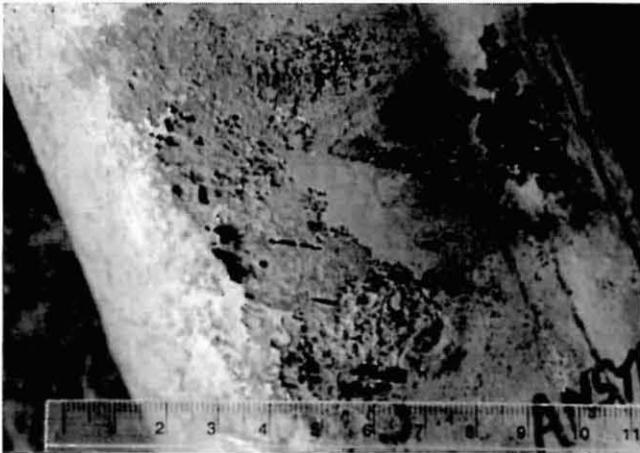
FIGURE 3. Area of corrosion on pipe, showing the parallel direction of the pitted areas

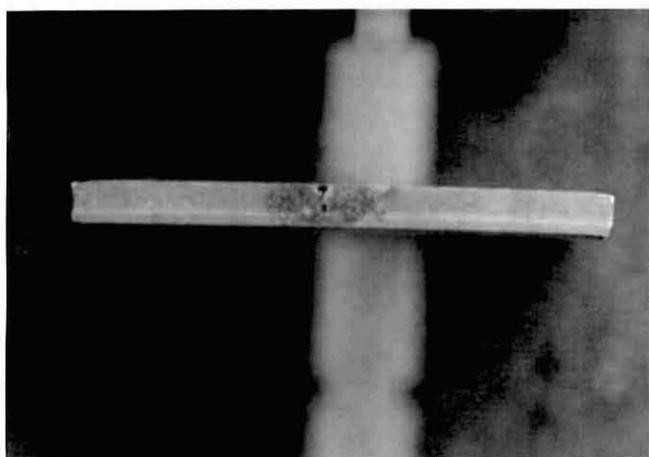
The corrosion attack on 3CR12 as noted in these studies deserves highlighting. In many instances, the coupons showed edge attack. In fact, pipes at six of the sites showed attack at the sheared edge. It may be considered that the duplex structure of 3CR12 results in a banded structure in the final rolled product. Many instances have been reported of incorrect guillotining, where shear break has occurred.

This phenomenon and the way to avoid it is well illustrated in the 3CR12 fabrication guide⁴. During the shearing process, a portion of the material is actually cut, followed by a breaking of the remaining cut face. This can cause microscopic opening of the broken area of the face, which, should corrosive attack be likely, will provide sites for pitting attack. This attack is clearly shown in Figure 4. It can be argued that this makes 3CR12 coupons more prone to attack than fabricated products where the edges are not exposed. It is contended that this is really the case only in MIC, where attack can be seen to follow the rolling direction as noted.

FIGURE 4. Corrosion on the sheared edge of a 3CR12 coupon from Anstey's Beach

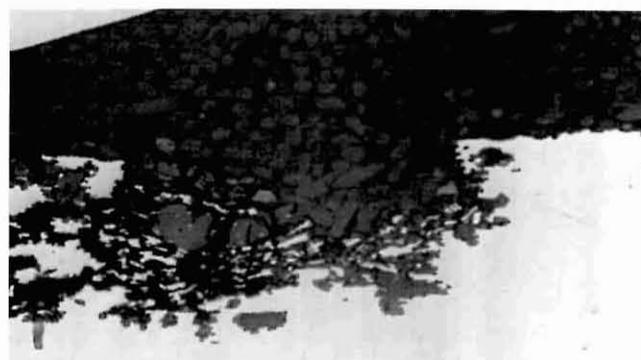
However, some further work will be needed to confirm these observations. It will be necessary to retrieve a pipe suffering from proposed MIC and return it to the laboratory within 24 to 48 hours so that the presence of SRB in the pits can be identified. In addition, redox measurements will be taken at sites suffering and not suffering from proposed MIC to see if the 200mV criterion is met³. In conclusion, it can be assumed that, as the pitting attack on the pipes and coupons follows the rolling direction, the banded nature of 3CR12 causes MIC to follow the line of least resistance, i.e. to be intergranular in nature. This is shown in Figure 5.

FIGURE 5. Cross-section of a pit, showing the intergranular nature of the attack
