Bindura Nickel Smelter - from decommissioning, care and maintenance, to plant re-start

A. Mboma and K.D. Chitaukire

Bindura Nickel Corporation, Bindura, Zimbabwe

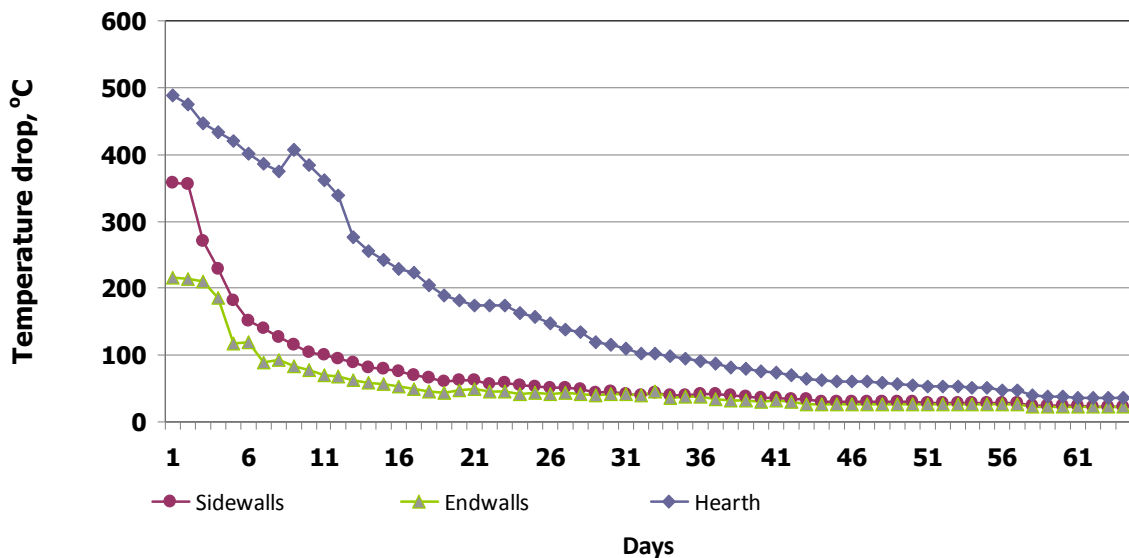
Figure 2: Refractory temperature drops during decommissioning

- On the side-walls, the greatest decrease in temperature was on thermocouple T3, revealing the melt dynamics during shutdown.
- For the end-wall thermocouples, the matte-end placed thermocouple T23 dropped the most, due to the furnace burn-down that aimed at removing the build-up in the furnace.
- The matte-end hearth thermocouple T18 dropped the most due to the furnace burn-down.

After switching the furnace power off, the temperature drop resulted in the contraction of refractory, and subsequently the furnace structure. A sharp increase in the hearth temperature occurred on Day 9, after switching off the hearth cooling fans, and this resulted in a rise in the hearth temperature (see Figure 2) as more energy was conducted from the hot hearth build-up through the refractory bricks.

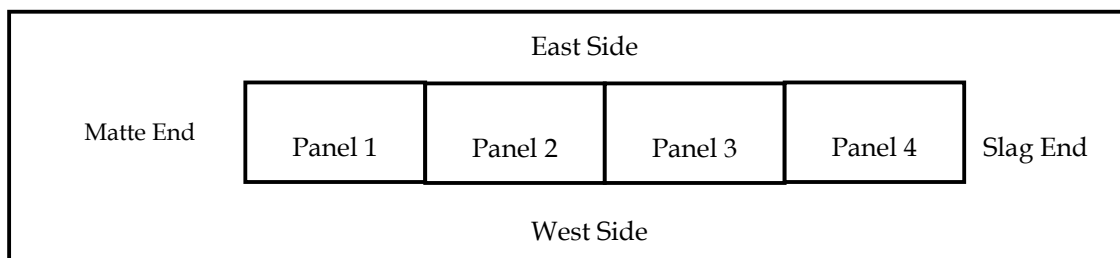
Figure 3: Furnace roof panels arrangement

The furnace roof moved upwards right from switching off, as a result of the drop in the temperature of the refractory bricks and their subsequent contraction. Of the four panels, panels 2 and 3 had the greatest movement, much higher than the normal 50 mm. Roof movements were then controlled by limiting the tonnage decrease on top cross springs to 17 t (normal working tonnage) and top long spring to 15 t (maximum working tonnage) from 9 March.

Panel	1	2	3	4
Movement (mm) (24.02.09)	-44	-35	-27	-10
Movement (mm) (09.03.09)	-17	22	22	28
Movement (mm) (30.04.09)	-27	30	31	39
Change (mm)	17	65	58	49

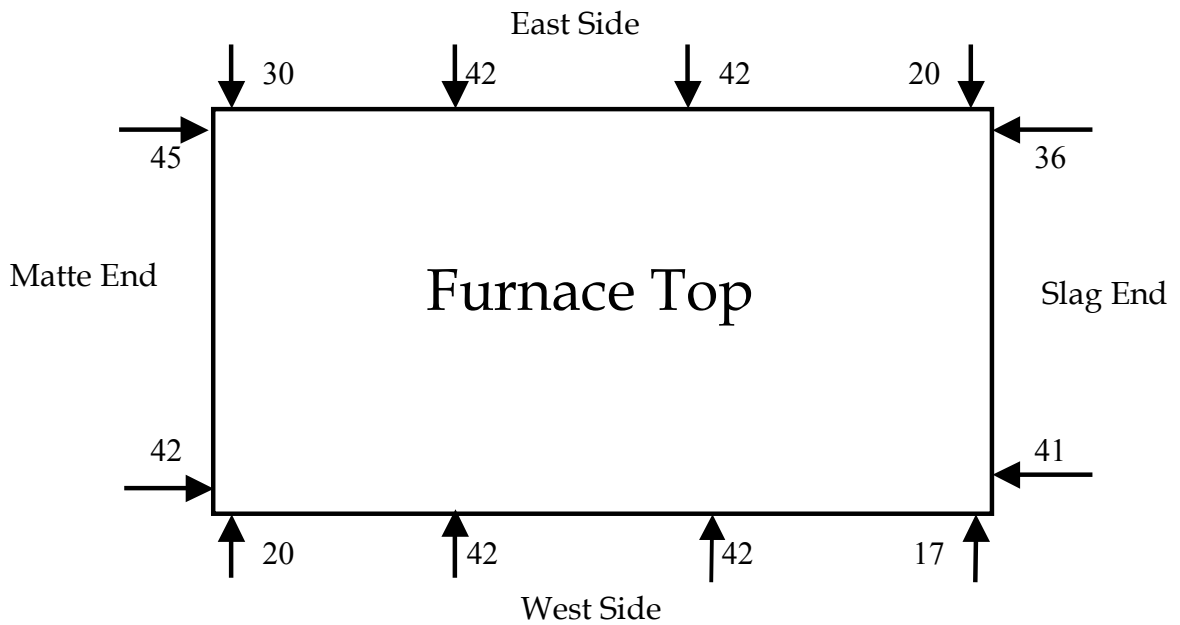
Figure 4: Lateral movements at the Furnace Top (upper section) in mm

Furnace Top: Contraction on the end-walls was relatively uniform, although the eastern matte-end side contracted the most by 45 mm. The side-walls contracted the most at the centre, where panels 4 and 5 contracted by 42 mm, as shown in Figure 4.

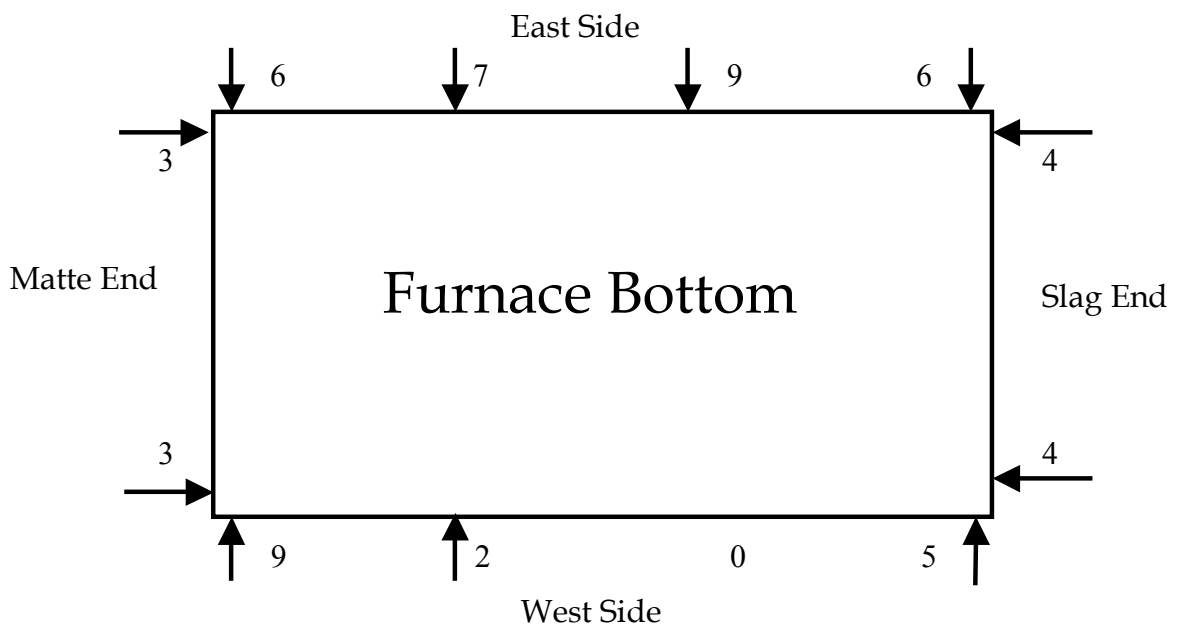
Figure 5: Furnace Bottom lateral movements (bottom section) in mm

Furnace Bottom or Hearth-end: The furnace contracted more at the slag-end than at the matte-end. The furnace bottom (hearth) had the least contraction on the side-walls, with a maximum of 9 mm, indicating the relative stability of the hearth during the furnace cooling period, as shown in Figure 5.

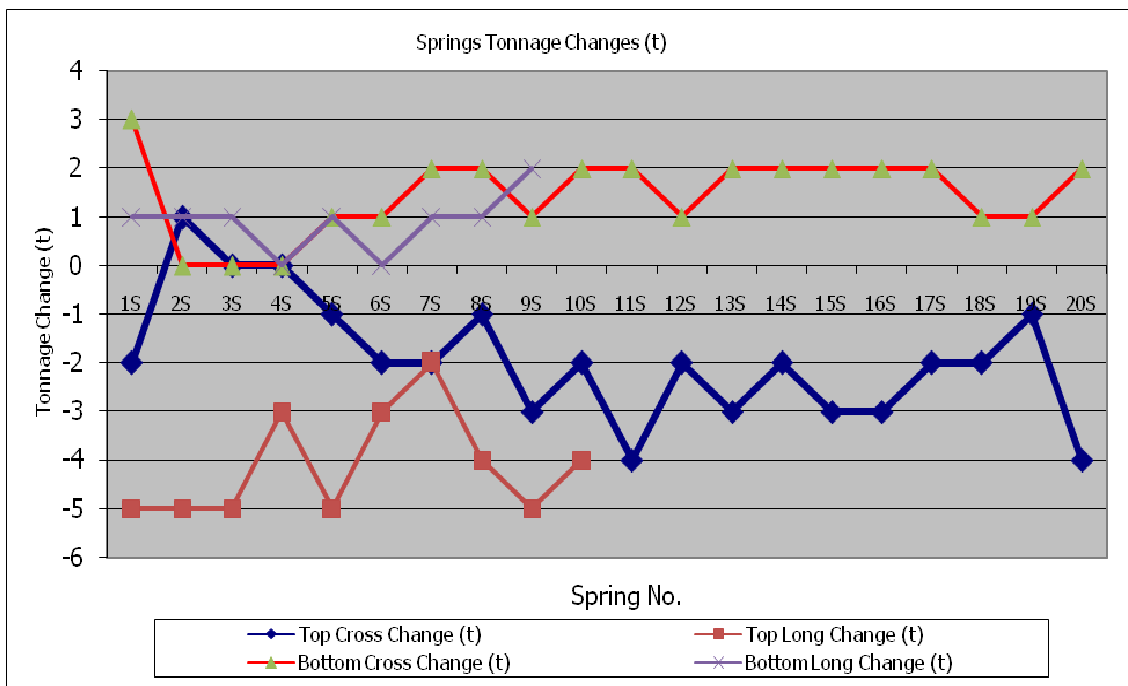
Figure 8. Tensional force changes for individual springs

Top Cross Springs: Major decreases in tensional forces were recorded on springs 11 and 20, which decreased by 4 t each at 21 t, as shown in Figure 8.

Top Long Springs: The biggest drops were on springs 1, 2, 3, 5, and 9, which dropped by 5 t each.

Bottom Cross Springs: At the end of the monitoring period, most of the springs were 2 t above the normal operating tensional forces, which was within measurement error.

Bottom Long Springs: At the end of the monitoring period, most of the springs were 1 t above the normal operating tensional forces, which was also within measurement error.

It is quite evident from the spring tensional monitoring that the furnace integrity was well maintained throughout the cooling duration.
