Challenges and solutions in PGM furnace operation: high matte temperature and copper cooler corrosion

by A. Shaw*, L.P.v.S. de Villiers†, R.J. Hundermark†, J. Ndlovu†, L.R. Nelson†, B. Pieterse†, R. Sullivan*, N. Voermann*, C. Walker*, F. Stober*, and A.D. McKenzie‡

Synopsis

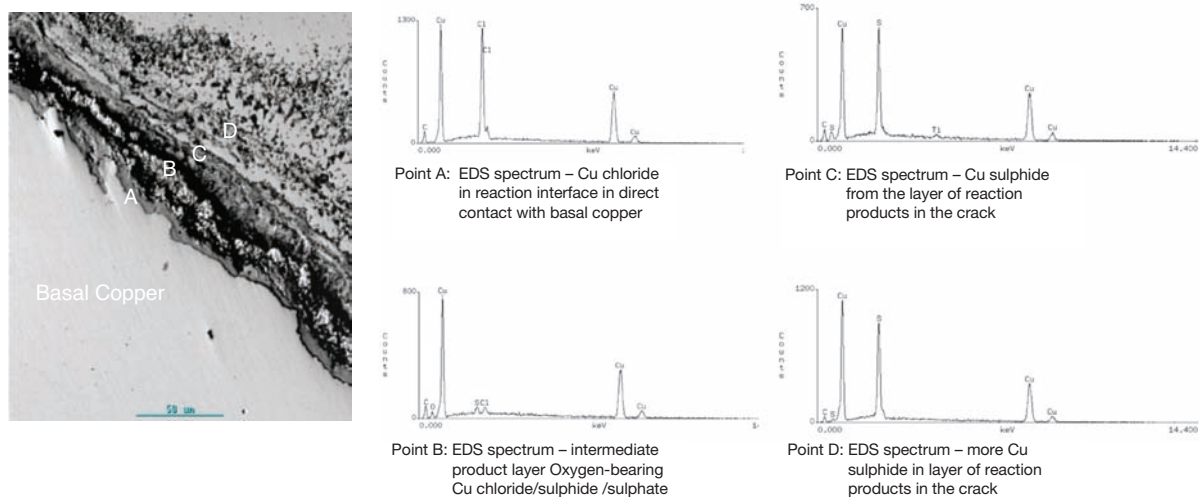
Figure 8—BSE image inside of a copper crack extending from a corrosion pit - typical sequence of corrosion product layers

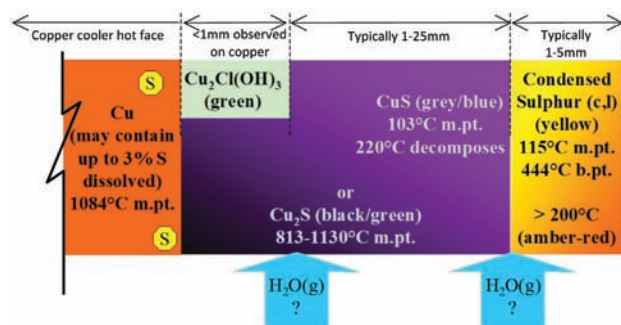
Figure 9—Schematic depiction of copper cooler and dominant species in its corrosion

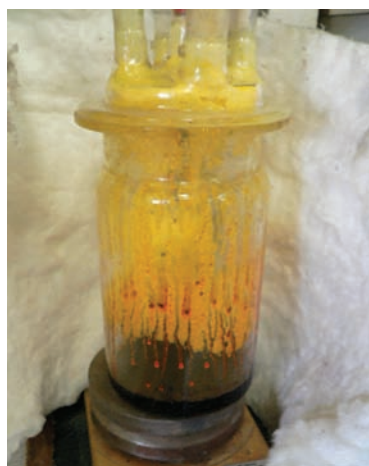
Figure 11—Sulphidation test rig with test sample inserted. Sulphur condensing and running down to liquid bath

To investigate this discrepancy, a special test rig was devised in an attempt to simulate copper cooler corrosion conditions. This comprised suspending water-cooled copper test blocks above a heated bath of sulphur, so exposing water-cooled copper to sulphur vapour (Figures 10–13). The results demonstrated that some direct sulphidation of water-cooled

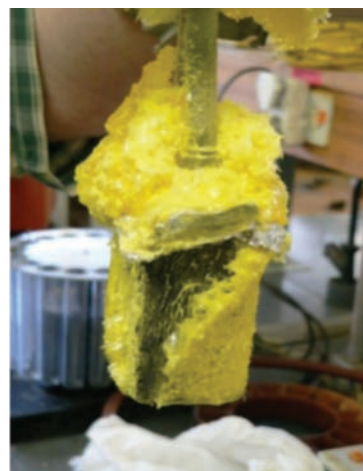
Figure 12—Water-cooled copper specimen coated with sulphur after testing

copper was indeed feasible even at a temperature as low as 25°C (0.2 mm over 14 days or 5.2 mm/a). As the copper temperature is raised to 90°C the corrosion rate increases to 16 mm/a. At a copper temperature of 125°C, the rate is

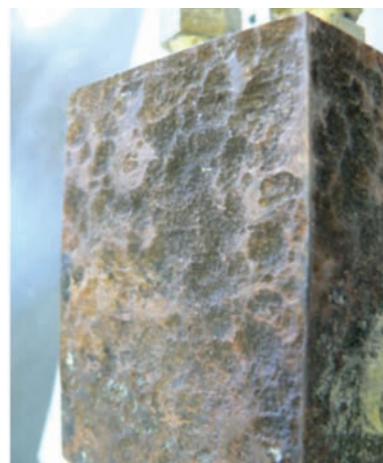
Figure 13—Copper corrosion at low 50°C temperature after only 5 days' exposure

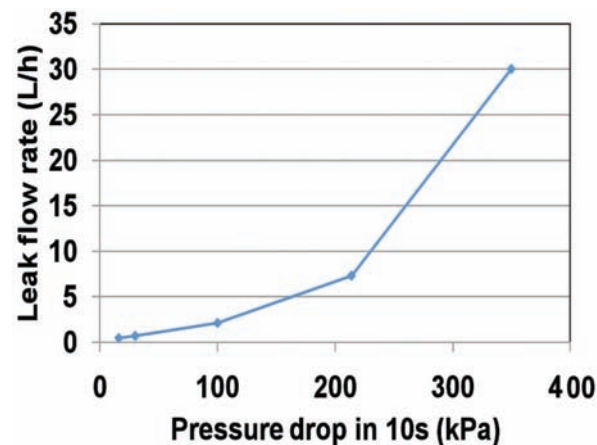
Figure 16—Leak simulation testing results indicating system sensitivity (Mahape, 2005)

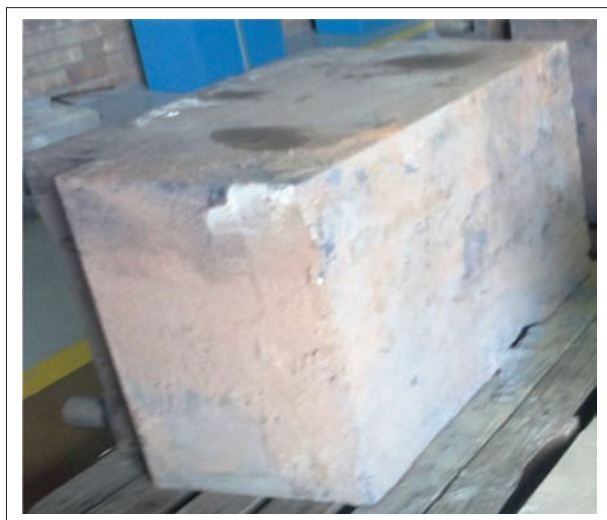
Figure 18—Upper cooler copper and graphite in pristine condition after being installed in the furnace for 12 months

Two consecutive planned annual inspections of the latest generation of graphite-protected copper coolers revealed the graphite to be in near pristine condition after 12 months' service. Given that the life of the original coolers was approximately one year, these results are very positive.

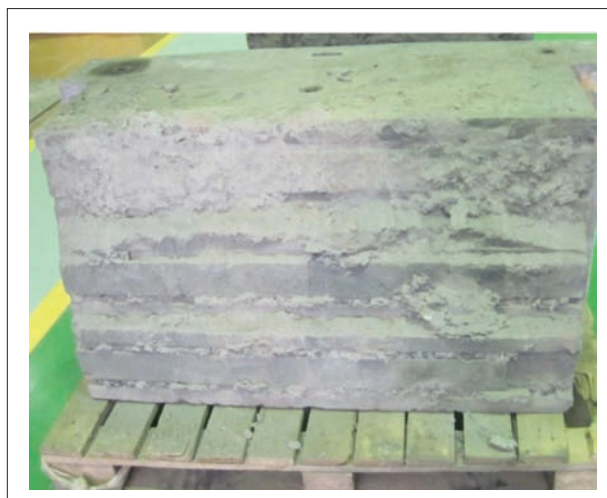
Figure 19—Perfect lower cooler graphite hot-face after being installed in the furnace for 12 months
