# Evaluation of Furnace Refractory Linings after Sixteen Years of Producing Silicomanganese

Paul O'Shaughnessy<sup>1</sup> and Ferdus Le Roux<sup>2</sup>

1. OCTC Limited, Hull, England
2. BHP Billiton, Johannesburg, South Africa

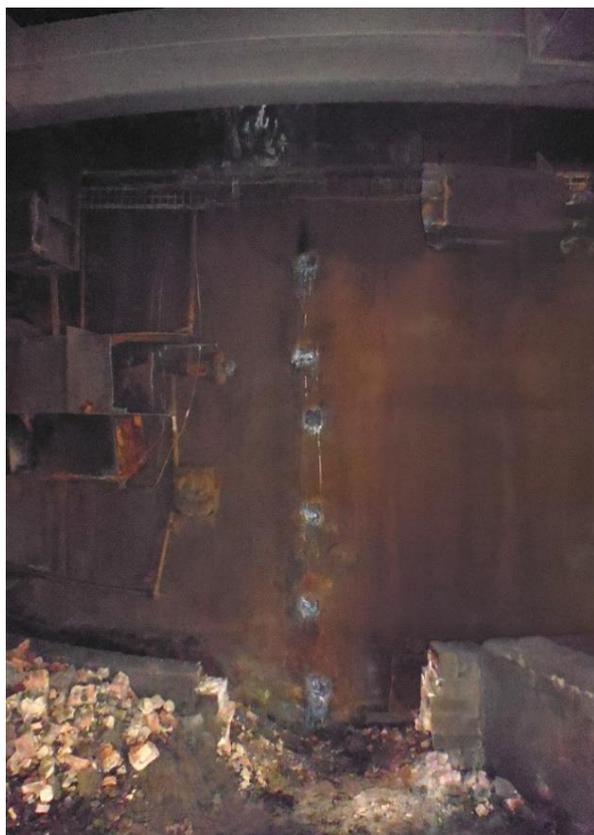
**Figure 9:** Work environment

The vertical sections, which are referred to as Levels, are shown by the shell cut-outs in Figure 9 below. Levels 1 to 3 are above, and Levels 4 to 6 are at and below the taphole centreline. The elevations on furnaces M1 and M4 are different because of practical considerations. Access to level 6 was generally problematic and required partial removal of concrete platforms. In addition, the water feed pipes and the return launder needed to be partially removed to allow for access to levels 5 and 6. Figures 10, 11 and 12 provide details of the core drilling equipment that was used.

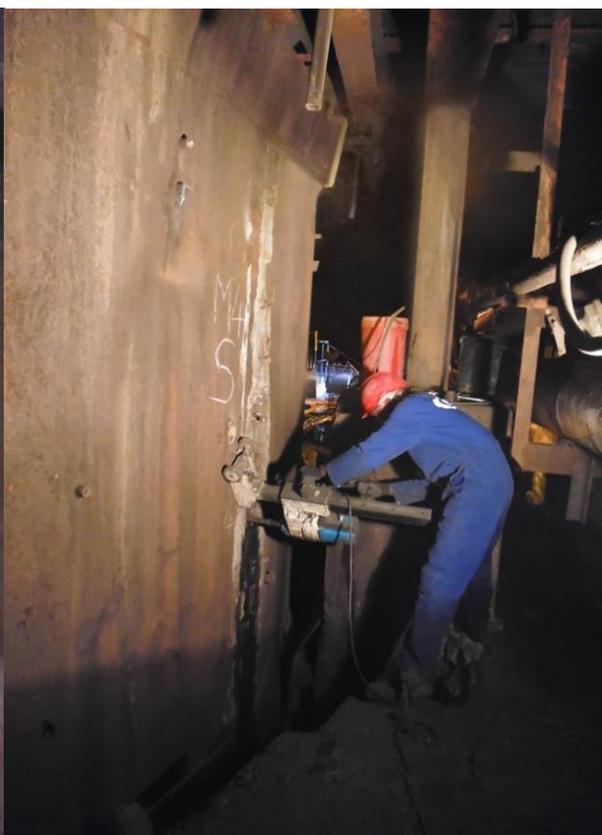
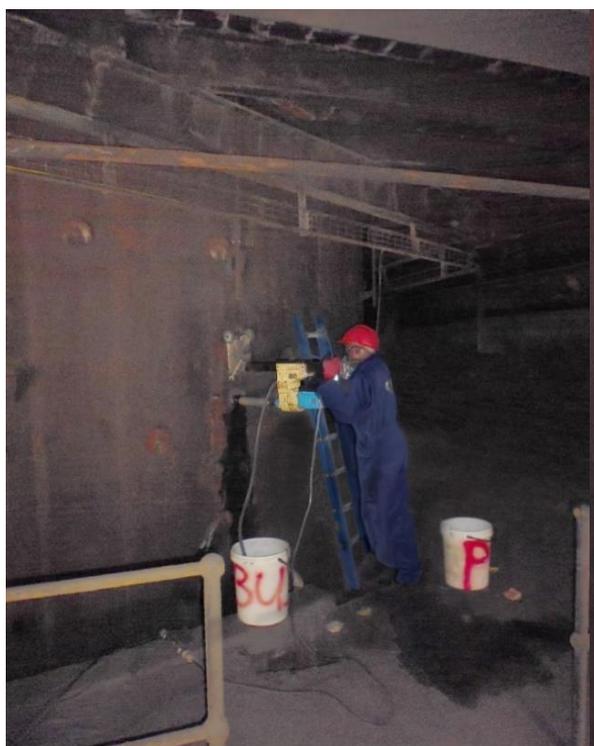
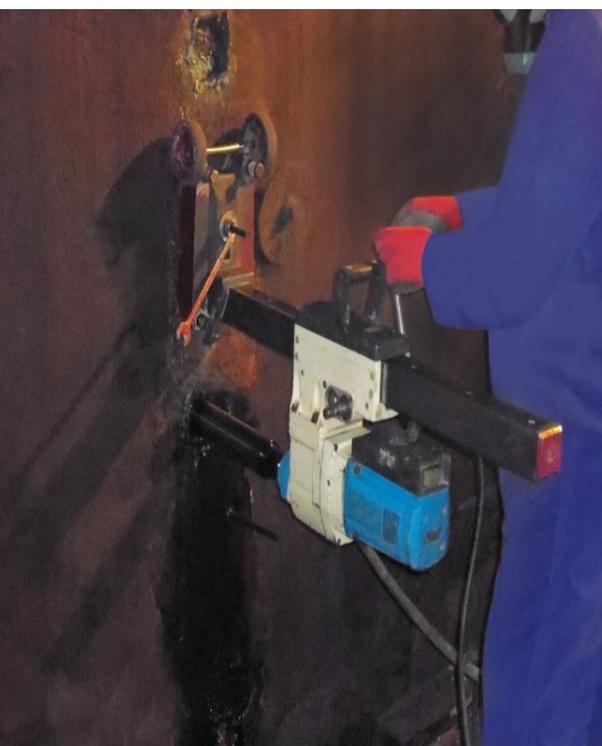
**Figure 10:** Core Drilling Equipment

**Figure 11:** Core Drilling Equipment

**Figure 12:** Drill Detail

A 50 mm diameter core was extracted. During the first stage, cores were drilled to a depth of 700 mm which is about 200 mm deeper than the carbon lining in the sidewalls outside of the tap hole abutment. At a second stage, the depth of some cores was extended a further 500 mm to complete data collection on the condition of the abutment and the extent of slag freeze.
