Study on the corrosion mechanism between MgO-CaO refractories and refining slag

Yanwen YU and Yuxi ZHAO
Baoshan Iron & Steel Co, Ltd., Shanghai 201941, China

Abstract: The refining AOD and VOD slag corrosion and penetration resistance of Magnesia-Calcia materials with different CaO from 22wt%-53 wt% were investigated by using static crucible technique along with visual observation, SEM and XRD measurements. The results showed that the resistance ability to corrosion and penetration of these materials decreased with the increase of CaO content in specimens. This could be due to the formation of C_3S and C_2S during the reaction between the specimen and high CaO content slag. The reaction between the molten slag and material also created a dense surface layer, which would restrain the further penetration by the slag. It was found that the depth of the layer penetrated either by AOD or VOD slag decreased with the increasing CaO content.

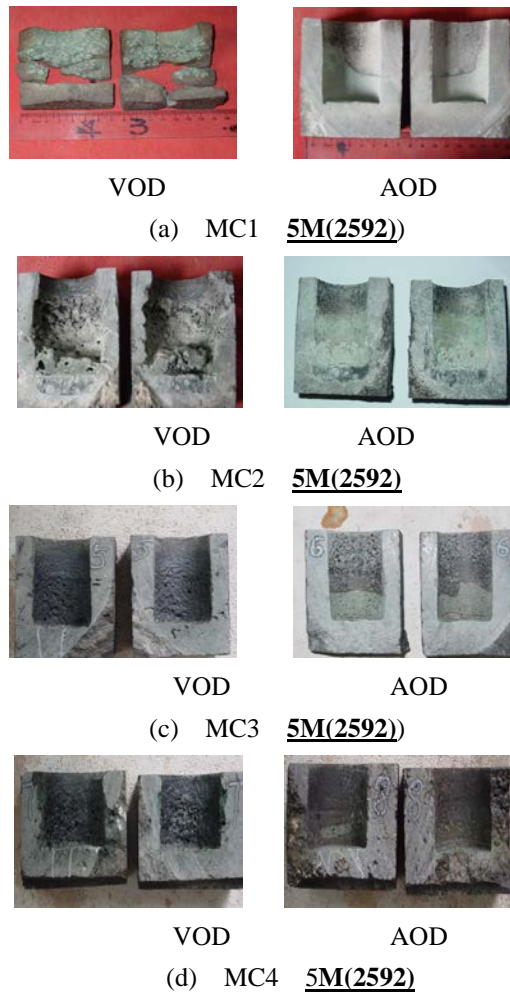
Fig.1 The cross sectional images for each of the crucibles MC1, MC2, MC3 and MC4

After the slag corrosion test, the cross sections of the crucibles had obvious corrosion and penetration. The images were as shown in Fig 1(a) to Fig 1(d). The four cross sectional images show us that the MgO-CaO brick's corrosion and penetration resistance against AOD slag was better than against VOD slag. The VOD slag reacted with MC1 intensively and cracked the brick after the test. The AOD slag corroded MC1 slightly and there were few residual slag deposits. After reacting with the VOD slag, the MC2 to MC4 crucibles showed different degrees of corrosion and penetration.

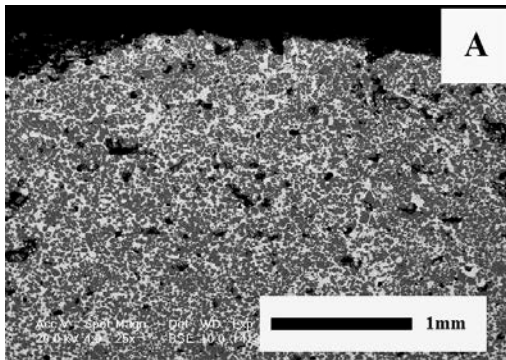
(a) Residual interface reacted with VOD slag

Fig.4 The SEM micrographs of residual MC1 corroded by VOD slag

Fig.4a is the micrograph of the residual MC1 interface contacting with VOD slag. It can be seen that there was no slag adhered on the interface. Fig.4b is the micrograph of 10mm area from the interface shown in Fig.4a. It can be seen that some residual CaO spherically covered C_3S , and a lot of C_2S formed by the reaction between the matrix and the slag. Moreover, the matrix became much more compact and was almost filled with aggregates over the whole block. The slag penetrated deeply, and most of CaO in the outer layer of matrix formed C_2S . The results of XRD analysis shown in Fig.5 also proved that the volume expansion of C_2S during the phase transition could be the cause of the crucible cracked.

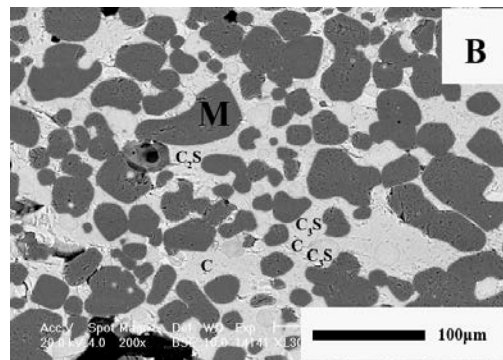
(b) 10 mm area contacting with the interface

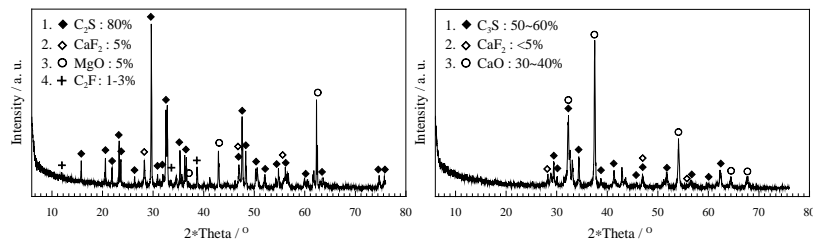
(a) Reacted with the VOD slag

(b) Reacted with the AOD slag

Fig.5 The XRD pattern of residual slag after reacted with refining slag

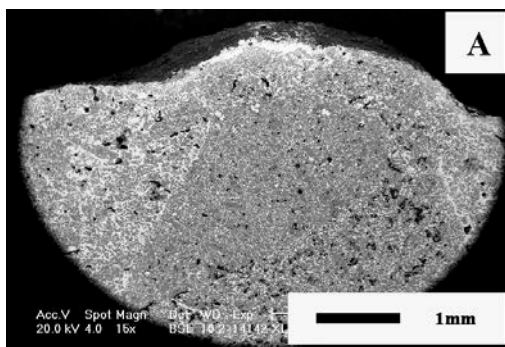
(a) Part of the residual slag

Fig.6 The SEM micrographs of MC1 corroded by AOD slag

Fig.6a and Fig.6b are the micrographs of the residual MC1 corroded by AOD slag. Fig.9a shows a part of the residual slag. The main phase was C_3S formed by the reaction between the AOD slag and the matrix. The reaction was restricted within the zone close to surface. Fig.6b is a micrograph of a part of the matrix where less slag penetration and small reaction degree can be found. In the matrix, 5~6 mm beyond the slag surface, there was almost no penetrative slag and the matrix became a dense sinter.

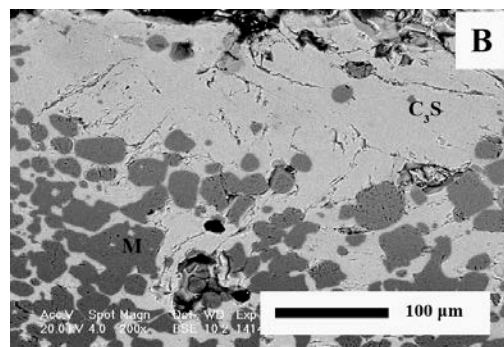
(b) Part of the matrix
