Bindura Nickel Smelter - from decommissioning, care and maintenance, to plant re-start

A. Mboma and K.D. Chitaukire

Bindura Nickel Corporation, Bindura, Zimbabwe

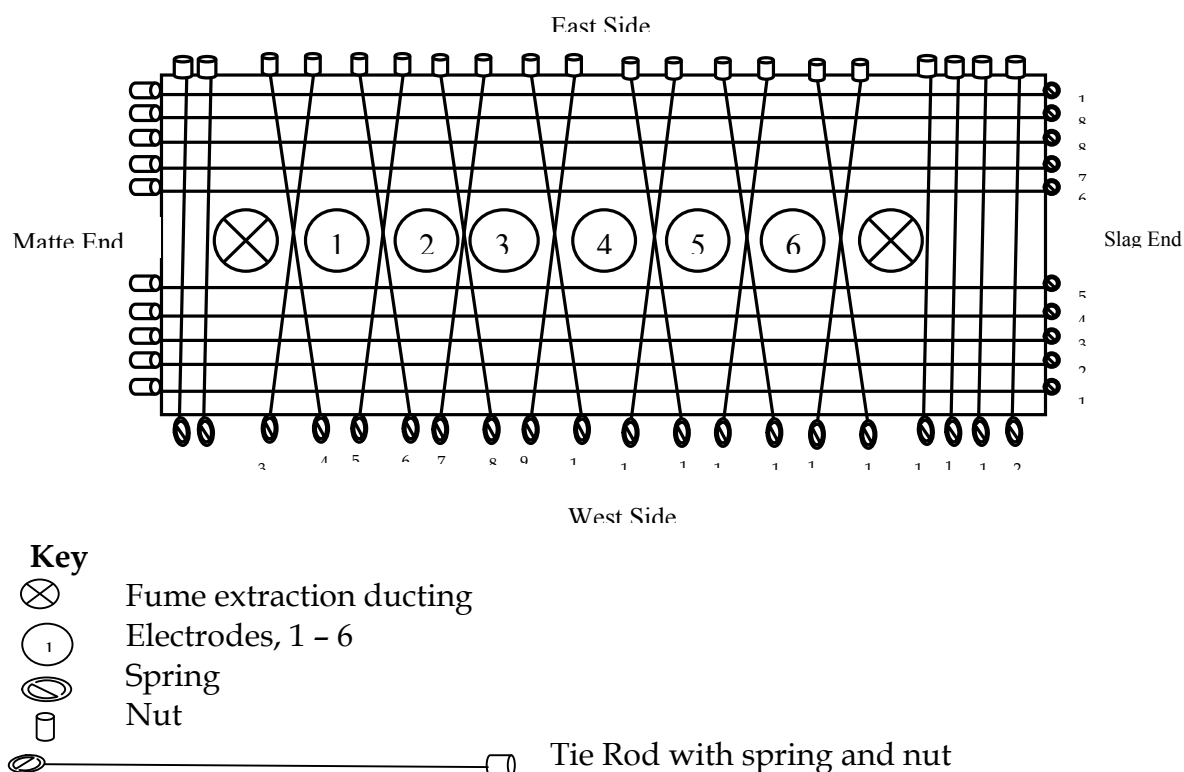
Figure 6: Furnace top springs aerial view arrangement

Top Cross Springs: Major decreases in tensional forces were recorded on springs 11 and 20, which decreased by 4 t each at 21 t, as shown in Figure 8.

Top Long Springs: The biggest drops were on springs 1, 2, 3, 5, and 9, which dropped by 5 t each.

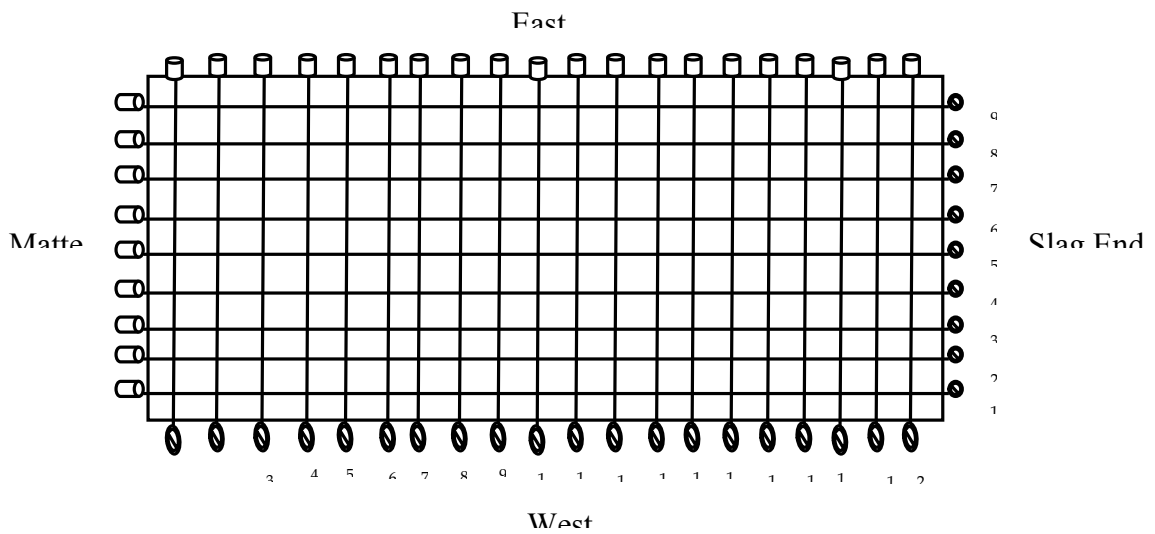
Figure 7: Furnace bottom springs aerial view arrangement

Most of the bottom springs had their tensional forces within the working range limit before the burn-down. During furnace monitoring, spring tensional forces were controlled at those used in normal practice. They continued to decrease, due to the drop in temperatures, but were adjusted back to their original tonnages before decommissioning.

Bottom Cross Springs: At the end of the monitoring period, most of the springs were 2 t above the normal operating tensional forces, which was within measurement error.
