NEW REFRACTORY LINING DIRECTION AT JINDAL STAINLESS FeCr #1 AND #2 FURNACES

C. Coetzee¹, P.H. Lamont², P.L Duncanson³, P. Sylven⁴

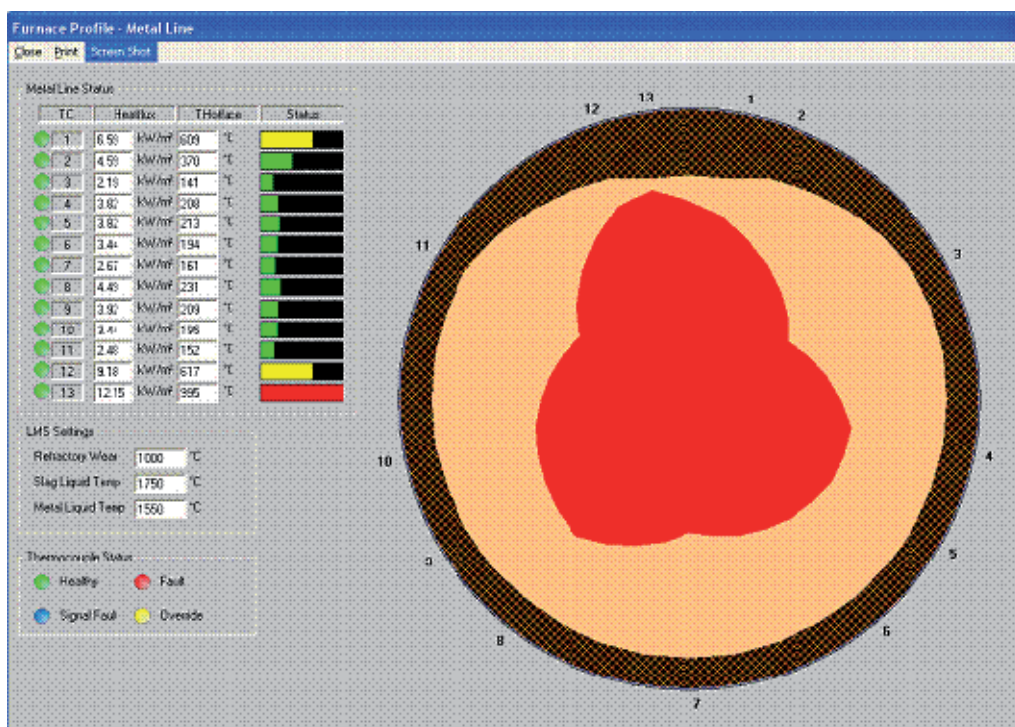
Figure 4: Clover profile at Metal line

In a GrafTech refractory lining, the hot face temperature of the carbon bricks should always be less than 600 deg C to prevent oxidation of the carbon brick. Figure 6 shows the clover profile of the lining. Higher temperatures are seen around the tap hole and across the electrodes. This is expected in any submerged arc furnace, and the heat flux in these areas is also higher than between the electrodes. Higher temperatures can also be attributed to the loss of protective skull, electrode lengths and breaks and also power input. Spikes in temperature should be carefully analyzed. The most important aspect of lining management is that spikes should return to normal and trending should be steady over a period of time. Any increase over time in all thermocouples temperatures should be taken very seriously and the reason(s) should be identified and rectified.

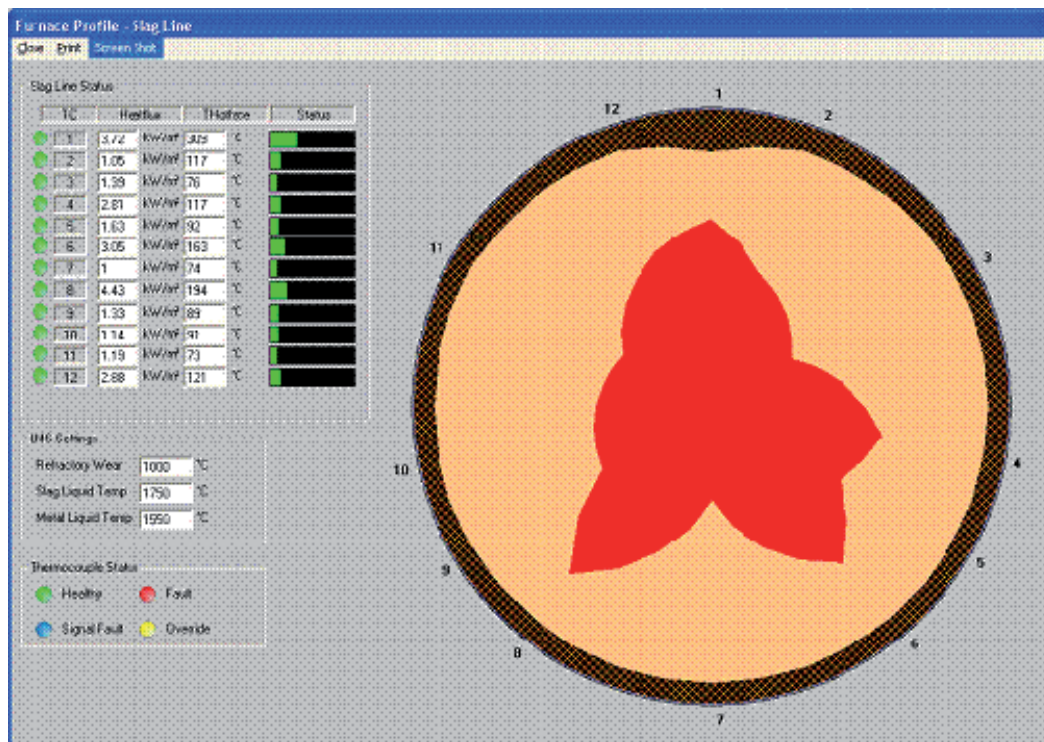
Figure 5: Clover profile at Slag Line

Figure 5 shows the clover position at the slag line. It was noted that this profile is significantly different than the metal line clover profile. Thermocouples #8 and #6 across electrodes at back, in particular, showed temperatures higher than the rest of the thermocouples on the slag line. In such a case, the reason may be electrodes running at a higher position in the furnace, or as discussed above, loss of skull. The temperatures are still very low compared to typical hot face temperatures on similar FeCr furnaces worldwide, thus no reason for further investigation/preventive actions at this stage. This furnace is currently running at approximately 32MW input, which is at the limit of the furnace design capacity. Any MW input higher than this will also result in lining temperatures increasing in the sidewalls, especially across electrodes.

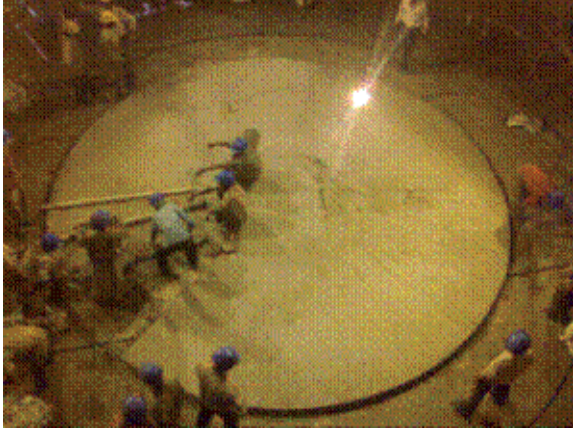
Figure 6: Pouring of Levelling castable

- 1. Check the level of the shell plate at bottom and install a levelling castable:** Before any brickwork could commence, IRCI, as well as plant personnel, conducted a proper steel inspection. The bottom plate was not level, but this could be rectified by means of a ceramic levelling castable. The steel shell was not completely circular with numerous flat spots and all welding joints had to be grinded flush. Figure 6 indicates pouring of the levelling castable.

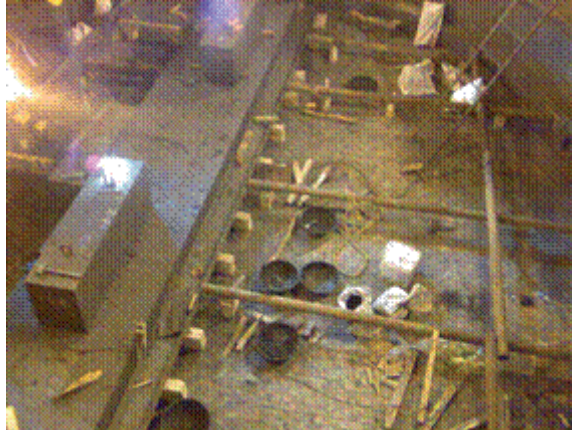
Figure 7: GradeD™ carbon block in hearth showing proper jacking by means of jacks and wooden poles

- 6. Proper Installation of GradeD™ Carbon Blocks:** Floor blocks were installed with extreme care so as not to damage any of them. Blocks entered the furnace on rollers and were handled inside the furnace by means of crawl beam and hoist. GrafTech requires a 1.7mm cement joint between the carbon blocks. This ensures that good thermal conductivity can be obtained between all the blocks. To ensure this good contact, all blocks were jacked by means of wooden poles and steel beams as seen in figure 7.

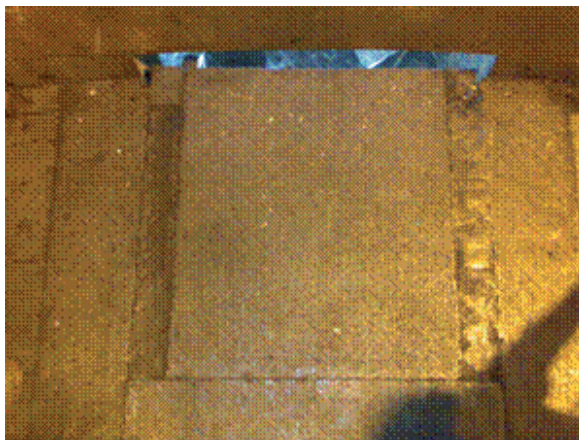
Figure 8: New and improved GrafTech tap hole configuration

- 9. Tap hole abutment installed according to GrafTech improved tap hole configuration:** Instead of only installing one carbon tap block, GrafTech has improved the tap hole configuration to improve lifetime and assist with changing of tap block during repairs. The new and improved configuration incorporates 2 carbon blocks instead of one solid block with a Smart Ram® RP20 ramming paste joints between two carbon side blocks. The RP20 will be broken out when changing a block, and the side blocks serve to protect the bricks in the abutment when break-out occurs. Instead, only the front block is broken out and replaced. This will also ensure shorter downtime while doing tap hole maintenance and repair. The new

and improved configuration can be seen from above in figure 8. Figure 9 shows the tap block and surrounding bricks as seen from outside of the furnace.

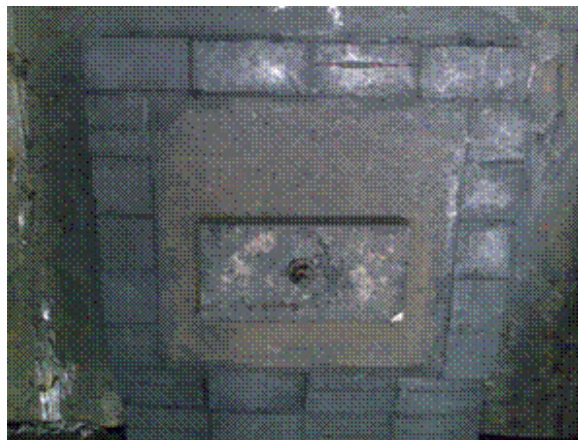
Figure 9: Tap block and surrounding bricks inside steel flange as see from outside of furnace
