Challenges and solutions in PGM furnace operation: high matte temperature and copper cooler corrosion

by A. Shaw*, L.P.v.S. de Villiers†, R.J. Hundermark†, J. Ndlovu†, L.R. Nelson†, B. Pieterse†, R. Sullivan*, N. Voermann*, C. Walker*, F. Stober*, and A.D. McKenzie‡

Synopsis

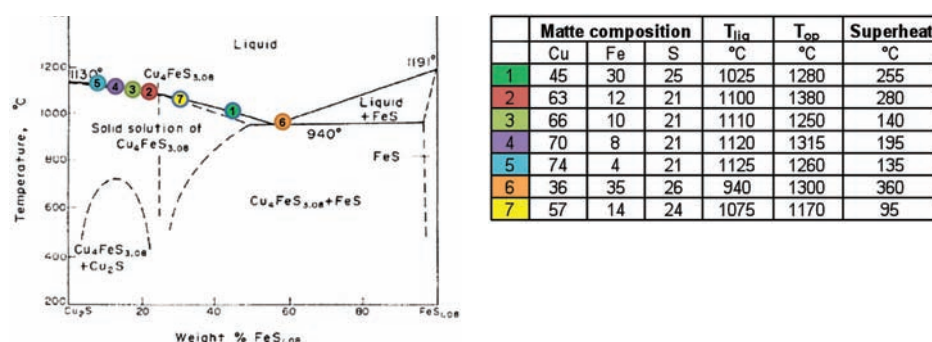
Figure 1—Copper primary matte liquidus temperatures (diagram after Schlegel and Schüller, 1952; matte composition information after Kapusta, 2004)

When one considers the copper matte formed in these furnaces, the matte liquidus temperatures range from around 940°C to around 1125°C, and a maximum difference of 360°C between the operating temperature and the matte liquidus temperature is observed (Figure 1).

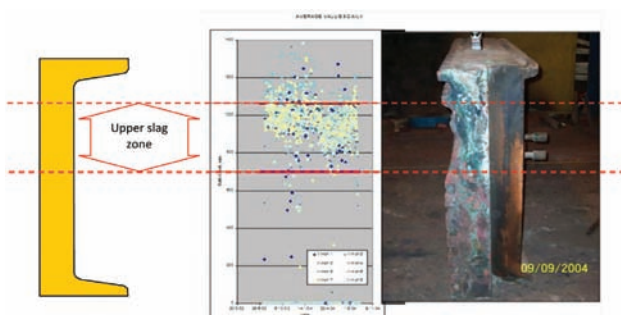
Figure 3—Location of maximum copper wear around slag-concentrate interface

In contrast to most other copper and nickel sulphide smelting operations, concentrate fed into PGM furnaces is not roasted. Corrosive species that are normally removed during concentrate roasting are instead released through heating and thermal decomposition of the concentrate in transit to and at the hot slag interface inside the furnace. These species tend to migrate and accumulate at the slag-concentrate interface near the walls, leading to pronounced wear of the coolers in this region (Figure 3).

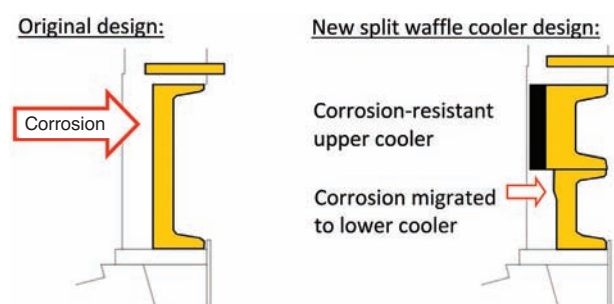
Figure 5—Initial copper loss in slag-concentrate interface zone. Following splitting of the coolers and protecting the upper block, copper corrosion migrated to the unprotected lower block

As part of the comprehensive plan to address corrosion, which is described later, the coolers were split horizontally into upper and lower blocks. After an effective corrosion-resistant barrier was applied to the hot face of the upper waffle coolers, the corrosion problem on these blocks significantly abated; however, the corrosion migrated to the 'deliberately' unprotected lower waffle coolers (Figure 5), though at a reduced rate.

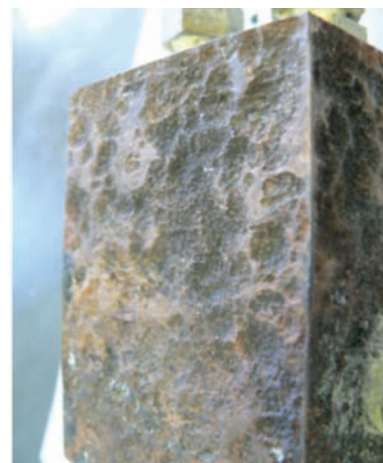
Figure 13—Copper corrosion at low 50°C temperature after only 5 days' exposure

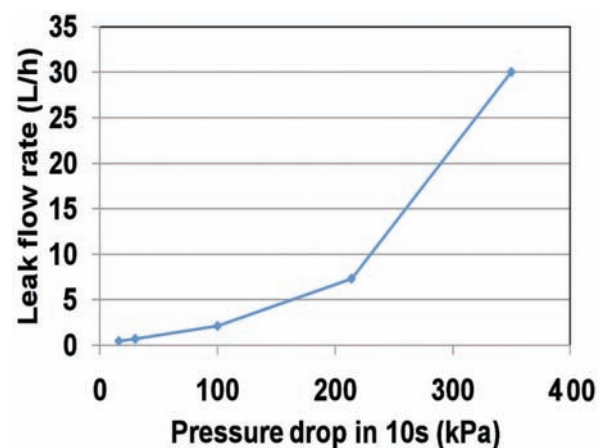
Figure 16—Leak simulation testing results indicating system sensitivity (Mahape, 2005)

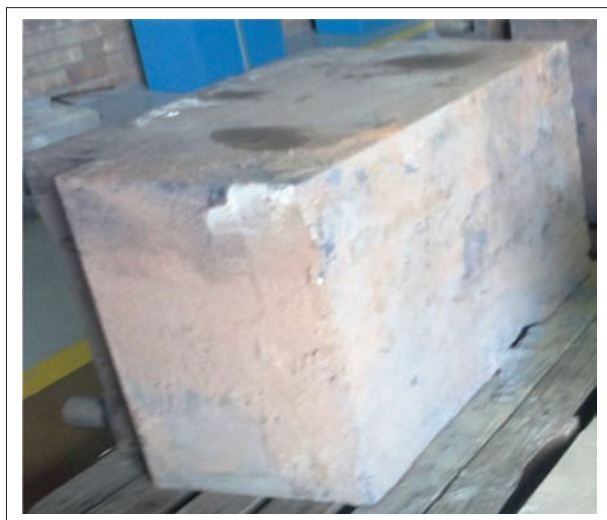
Figure 18—Upper cooler copper and graphite in pristine condition after being installed in the furnace for 12 months

Two consecutive planned annual inspections of the latest generation of graphite-protected copper coolers revealed the graphite to be in near pristine condition after 12 months' service. Given that the life of the original coolers was approximately one year, these results are very positive.

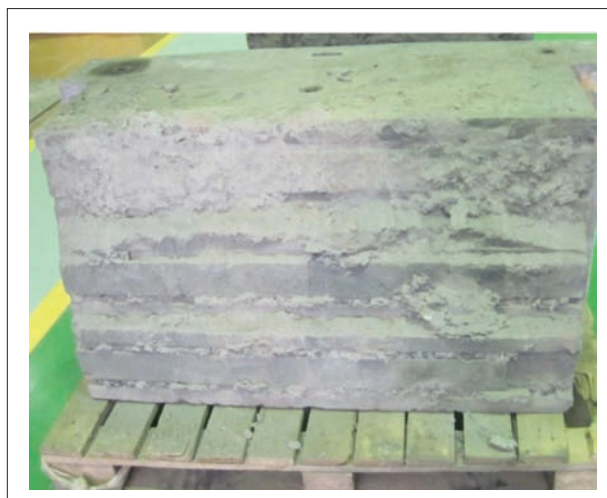
Figure 19—Perfect lower cooler graphite hot-face after being installed in the furnace for 12 months
